**PRECISION
MANUFACTURING
INC**

July, 2016

Infrared Inspection Report©

Precision Manufacturing Inc
123 Profitable Way
Anytown, State, Zip
Company Contact
John Doe
Project: 01100716

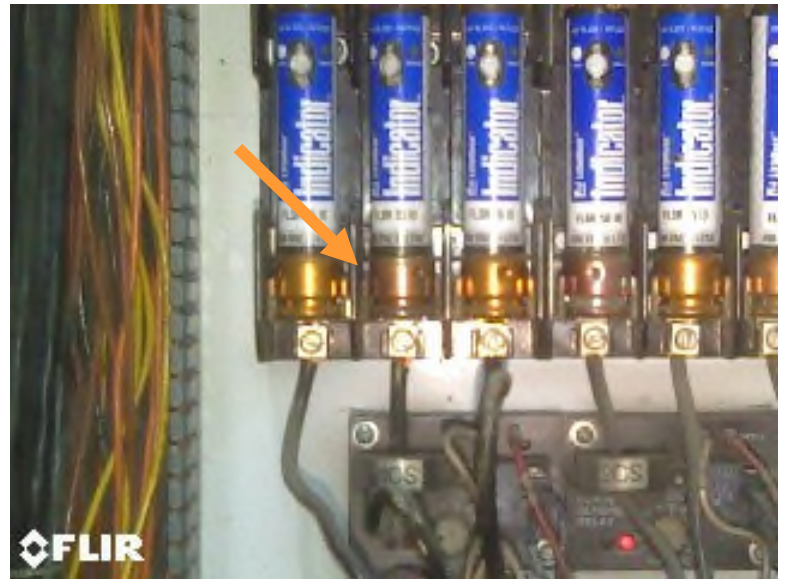
PROJECT: 01100716
 CUST REP: Mike
 SCAN REP: Level 2 Technician
 DATE: July 7, 2016
 LOCATION: 152 Oven Area
 Control Cabinet For:
 M1 Drive
 3ø Fused Circuit Labeled:
 3FU

ITEM: Bø Fuse Block
 SOURCE: Load side fuse clip.
 TEMP: Temp. of fuse clip is:
 101°C / 214°F Total Temp
 - 49°C / 120°F AOT
 = 52°C / 94°F above AOT.

Note: AOT is High.

Abnormal heat is being generated in fuse block component. See orange arrows in PH#11 and TH#11.

Loose and/or corroded contact area. Clean, inspect and re-secure serviceable components.
