**PRECISION  
MANUFACTURING  
INC**

***Infrared Inspection Report***©

Precision Manufacturing Inc  
123 Profitable Way  
Anytown, State, Zip  
**Company Contact**  
John Doe  
**Project:** 01100718

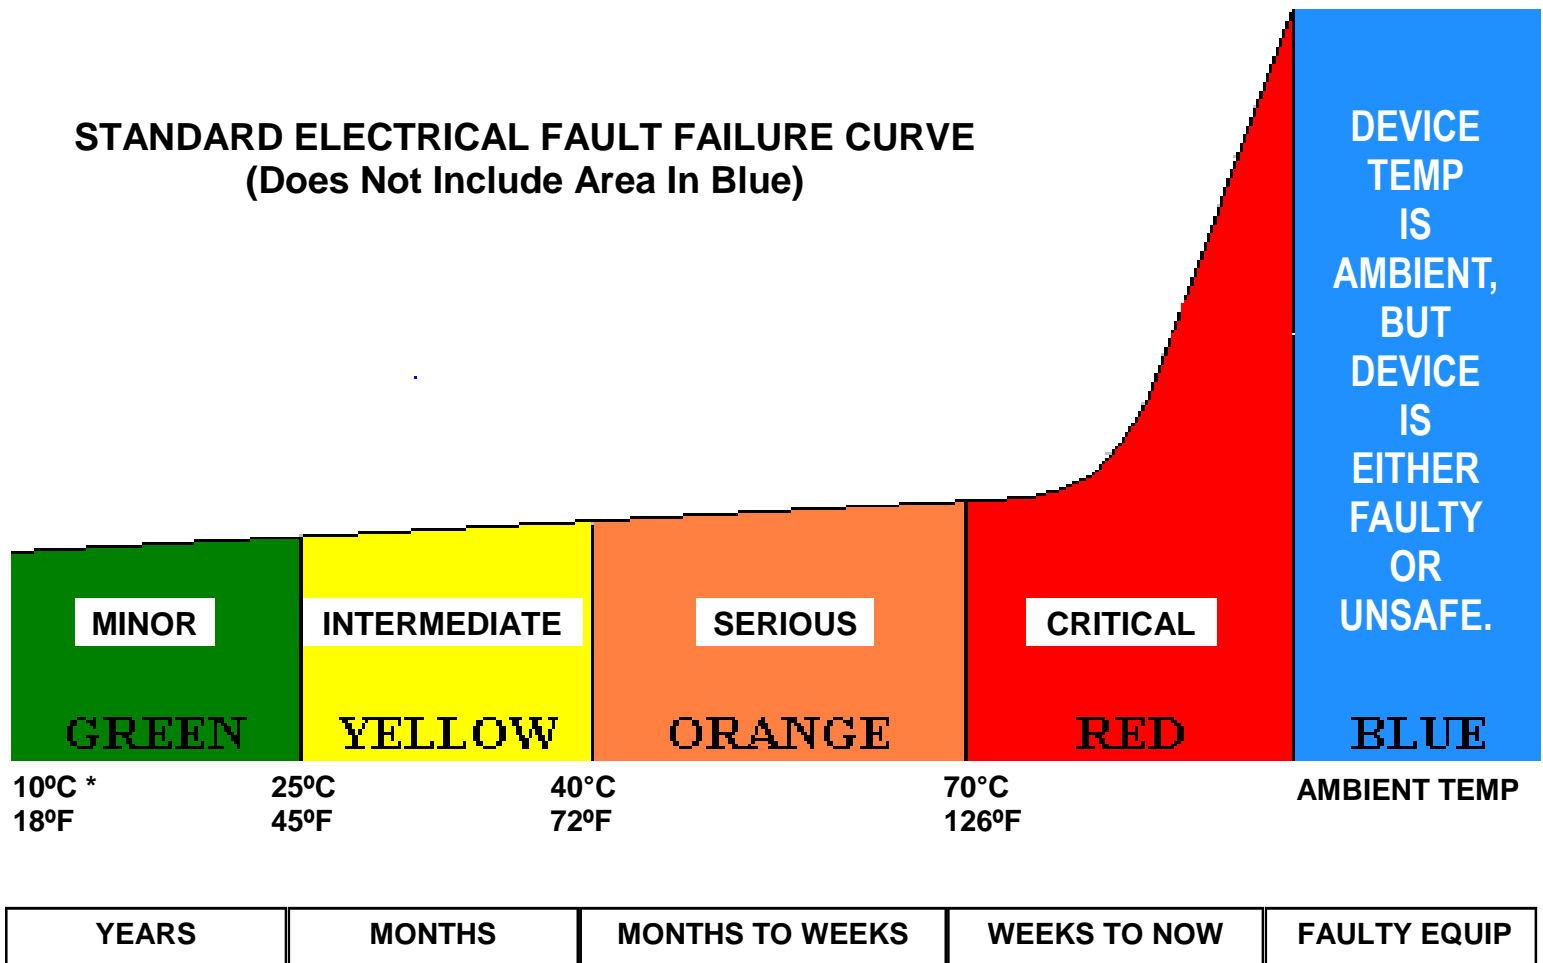
Electrical equipment failures generally follow a standard mechanical/electrical failure curve. Dividing the failure curve into temp. ranges and locating a problems position on the curve allows us to indicate the probable time to its failure. Knowing a problems probable time to failure allows you to make a cost effective response to the problem areas that we locate.

Below is a depiction of the electrical fault failure curve with the thermal intensity ranges and the colors that we assign to faults detailed in our reports.

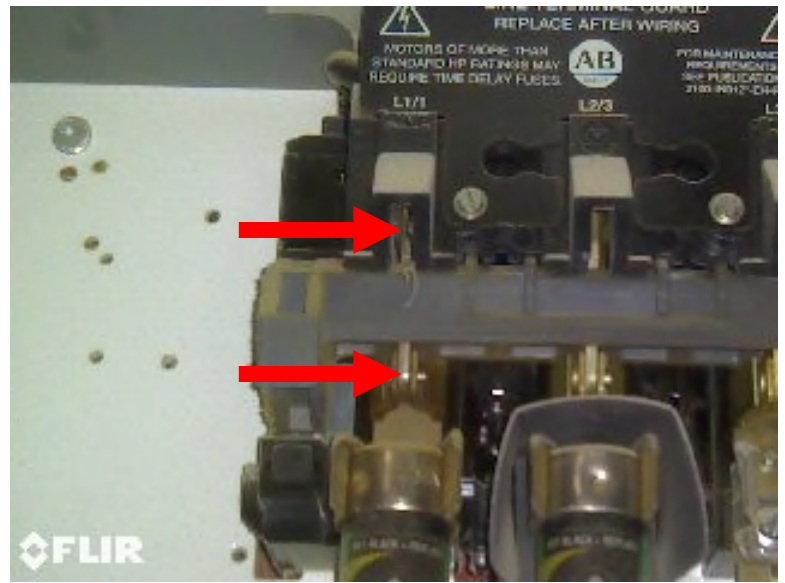
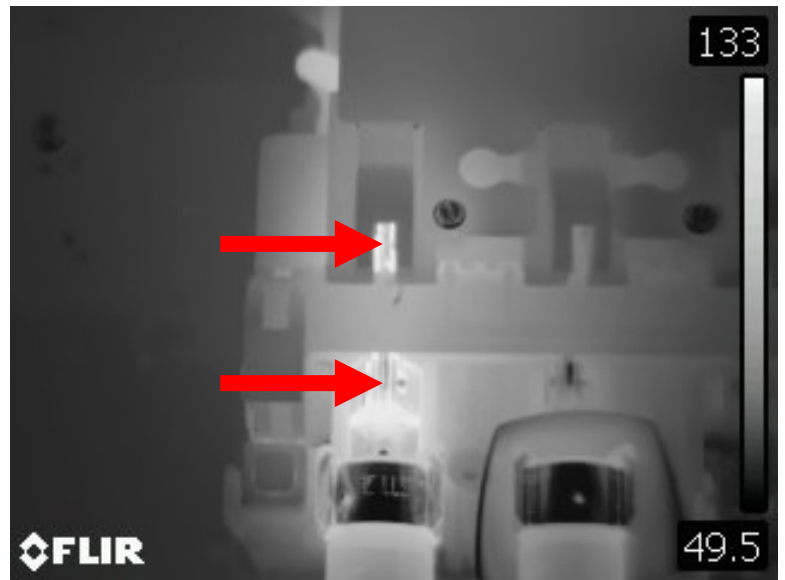
PH # 1 >

PROJECT: 01100718  
 CUST REP: Mike  
 SCAN REP: Level 2 Technician  
 DATE: July 7, 2018  
 LOCATION: Power Center 1  
 Box For:  
 Foundry Lab Oven "R"  
 Fuse Disconnect

ITEM: Aø of Disconnect  
 SOURCE: Line & load side disconnect blade contact area.  
 TEMP: Temp. of contact areas range to:  
 145°C / 293°F Total Temp  
 - 66°C / 151°F AOT  
 = 79°C / 142°F above AOT.

**Note: AOT is Very High**

Abnormal heat is being generated in disconnect components. See red arrows in PH#1 and TH#1.

**TEMPERATURE ABOVE  
 AOT  
 79°C / 142°F**

Loose and/or corroded contact areas. Clean, inspect and re-secure serviceable components.

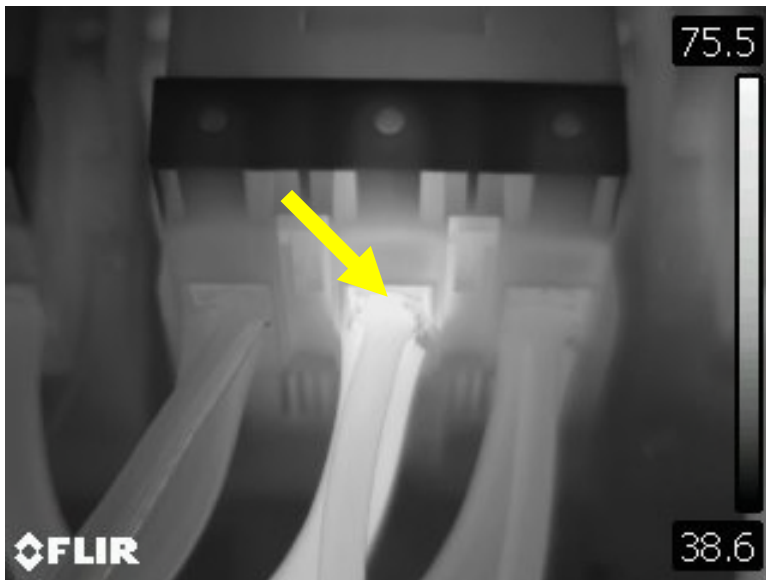
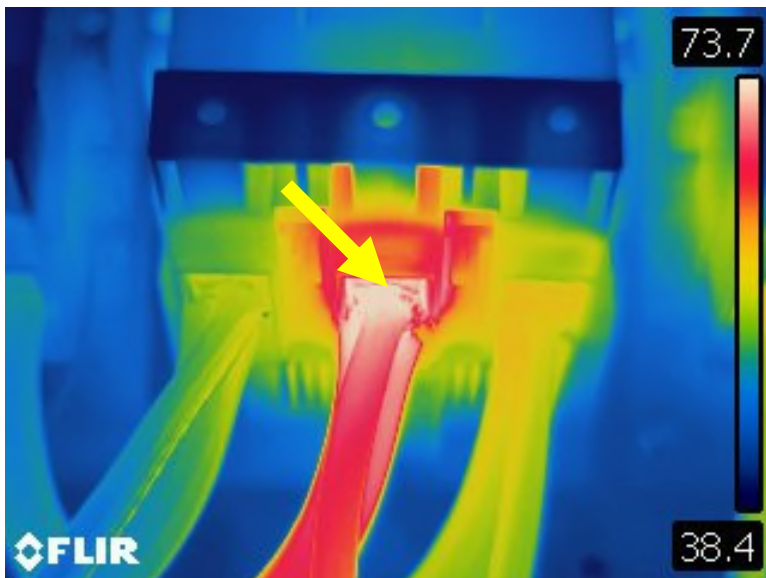
< PH # 2

PROJECT: 01100718  
 CUST REP: Mike  
 SCAN REP: Level 2 Technician  
 DATE: July 7, 2018  
 LOCATION: Compressor Room  
 (Downstairs)  
 Control Cabinet Labeled:  
 Cooling Tower Compressor  
 CTW0762  
 Motor Control Labeled:  
 M3

ITEM: Bø of Motor Control Contact Block  
 SOURCE: Load side lead connection lug.  
 TEMP: Temp. of connection and lug is:  
 81°C / 178°F Total Temp.  
 - 45°C / 113°F AOT  
 = 36°C / 65°F above AOT.

**Note: AOT is High**

Abnormal heat is being generated in motor control connection. See yellow arrows in PH#2 and TH#2.

**TEMPERATURE ABOVE  
 AOT  
 36°C / 65°F**

Loose and/or corroded contact area. Clean, inspect and re-secure.

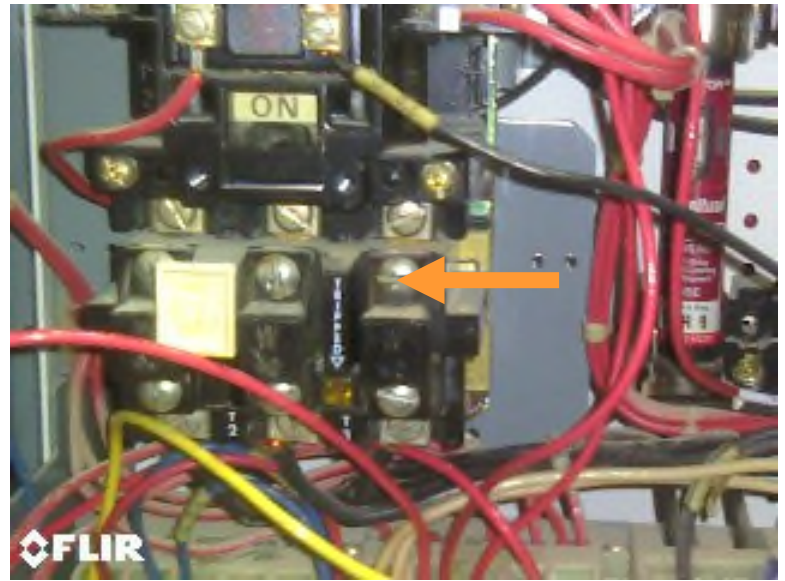
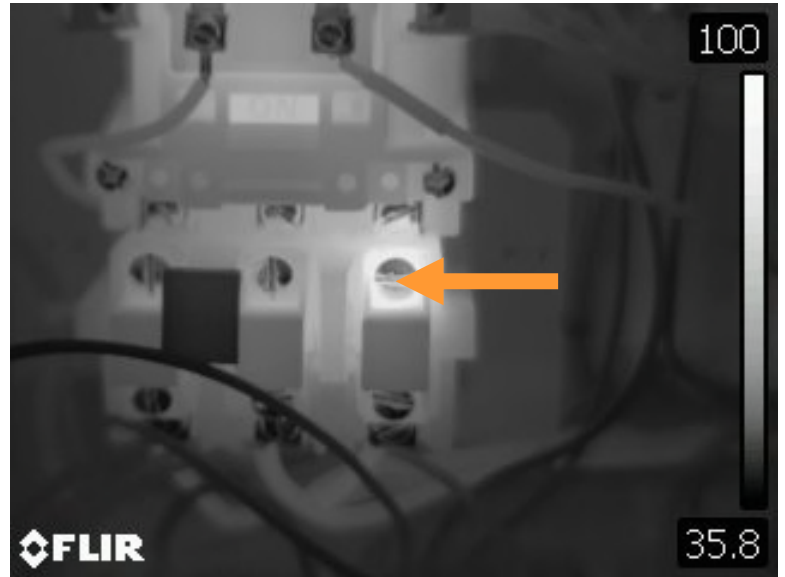
PH # 3 >

PROJECT: 01100718  
CUST REP: Mike  
SCAN REP: Level 2 Technician  
DATE: July 7, 2018  
LOCATION: Compressor/Vacuum Pump Room (Upstairs)  
Box Labeled:  
#1 Nash Vac Pump 2  
Combination Starter

ITEM: Cø of Motor Control Overload Relay  
SOURCE: Line side heater connection lug.  
TEMP: Temp. of connection and lug is:  
110°C / 230°F Total Temp.  
- 45°C / 113°F AOT  
= 65°C / 117°F above AOT.

Note: AOT is High

Abnormal heat is being generated in motor control component. See orange arrows in PH#3 and TH#3.

TEMPERATURE ABOVE  
AOT  
65°C / 117°F

Loose and/or corroded contact area. Clean, inspect and re-secure serviceable components.

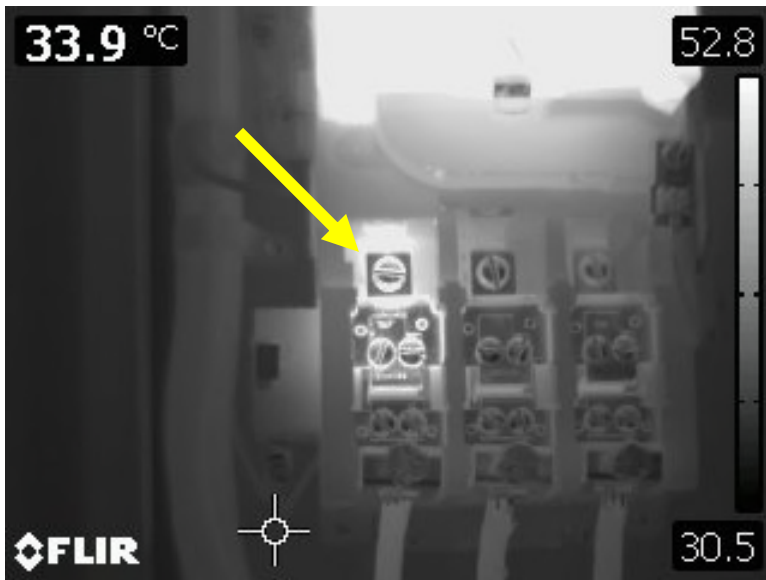
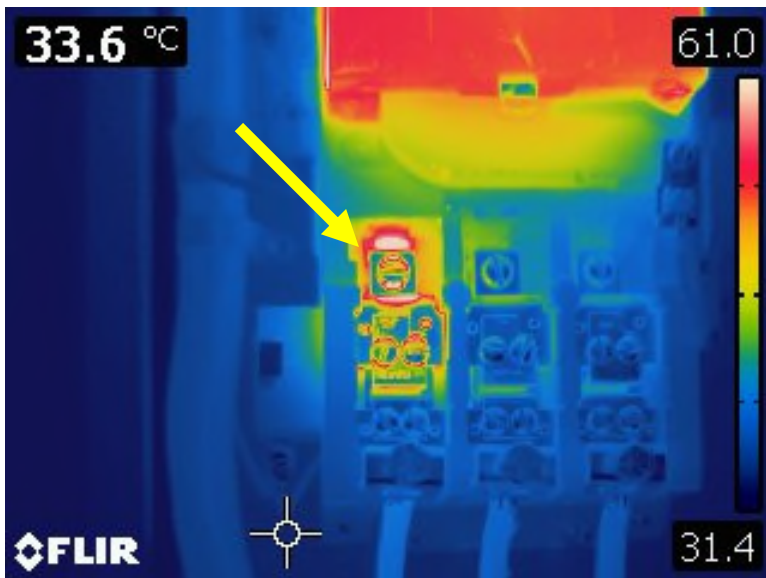
< PH # 4

PROJECT: 01100718  
 CUST REP: Mike  
 SCAN REP: Level 2 Technician  
 DATE: July 7, 2018  
 LOCATION: Compressor/Vacuum Pump Room (Upstairs)  
 Box Labeled: #3 Nash Combination Starter

ITEM: AØ of Motor Control Contact Block  
 SOURCE: Load side buss connection lug.  
 TEMP: Temp. of connection and lug is:  
 65°C / 149°F Total Temp.  
 - 34°C / 93°F AOT  
 = 31°C / 56°F above AOT.

Abnormal heat is being generated in motor control connection. yellow arrows in PH#4 and TH#4.

**TEMPERATURE ABOVE AOT  
 31°C / 56°F**

Loose and/or corroded contact area. Clean, inspect and re-secure.

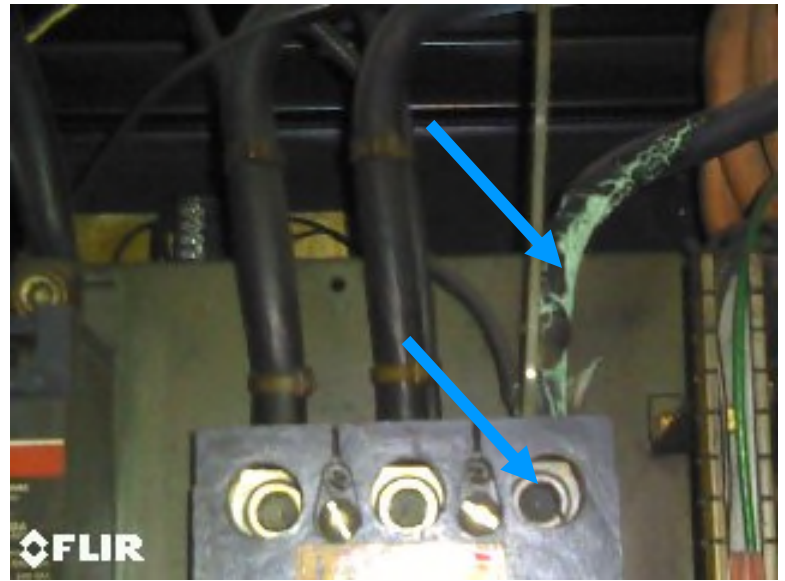
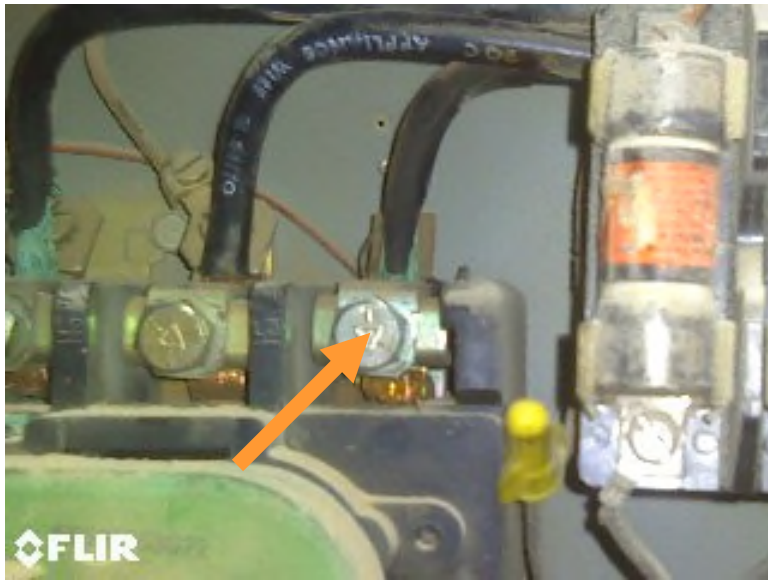
PH # 5 >

PROJECT: 01100718  
CUST REP: Mike  
SCAN REP: Level 2 Technician  
DATE: July 7, 2018  
LOCATION: Compressor/Vacuum Pump Room  
(Upstairs)  
Control Cabinet Labeled:  
#3 Sullair  
Molded Case Breaker Labeled:  
Compressor

**ITEM:** Cø of Case Breaker  
**SOURCE:** Line side lead connection lug.  
And  
Line side lead is breaking down  
**TEMP:** Temp. is Ambient.

**Note: Connections show heat discoloration and insulation is cracked and melted.**

Abnormal heat has been generated in case breaker connection. See blue arrows in PH#5 and TH#5.

**TEMPERATURE IS  
AMBIENT**

Loose and/or corroded contact area. Clean, inspect and re-secure serviceable components.

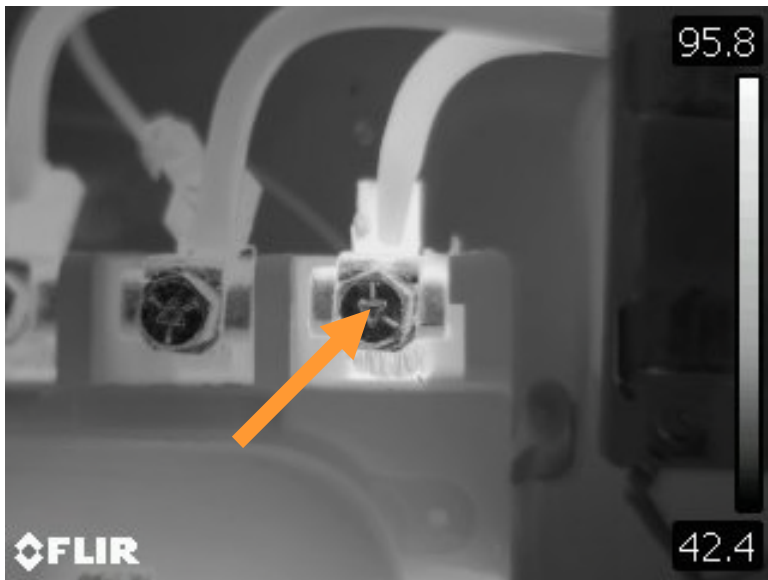
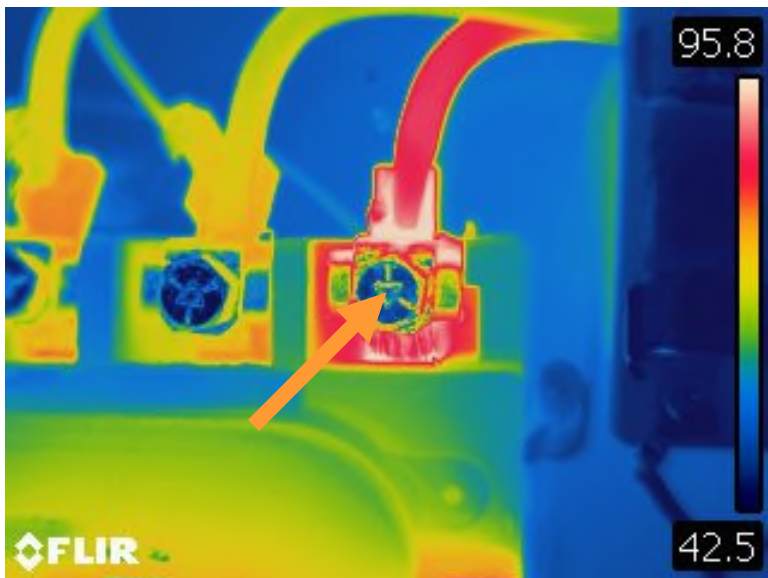
< PH # 6

PROJECT: 01100718  
CUST REP: Mike  
SCAN REP: Level 2 Technician  
DATE: July 7, 2018  
LOCATION: Filter Line Area  
Unlabeled Box:  
Mounted on Column F20  
Combination Starter

ITEM: Cø of Motor Control Contact Block  
SOURCE: Line side lead connection lug.  
TEMP: Temp. of connection and lug is:  
105°C / 221°F Total Temp.  
- 45°C / 113°F AOT  
= 60°C / 108°F above AOT.

**Note: AOT is High  
Connection shows heat discoloration and insulation is cracked and melted.**

Abnormal heat is being generated in motor control connection. See orange arrows in PH#6 and TH#6.

**TEMPERATURE ABOVE  
AOT  
60°C / 108°F**

Loose and/or corroded contact area. Clean, inspect and re-secure serviceable components.

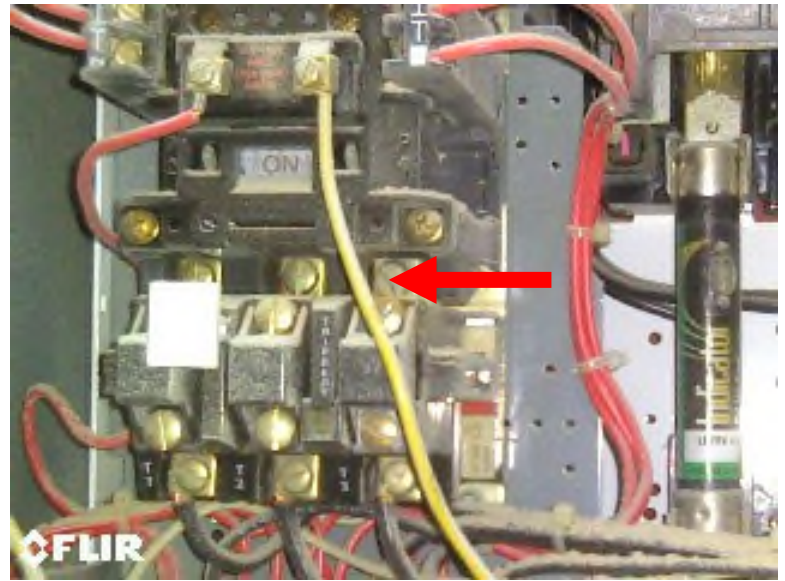
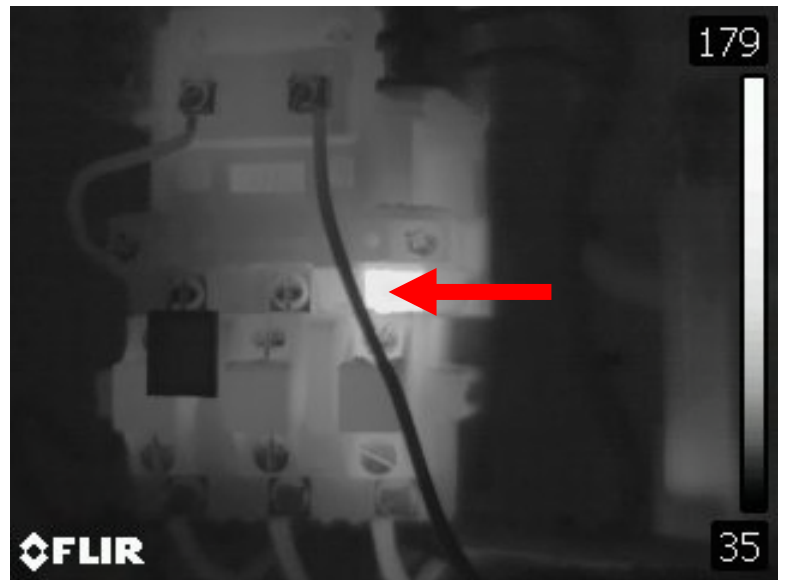
PH # 7 >

PROJECT: 01100718  
CUST REP: Mike  
SCAN REP: Level 2 Technician  
DATE: July 7, 2018  
LOCATION: Precision Sleeve Area  
Box Labeled:  
H4 Tank 1 Agitator  
Combination Starter

ITEM: Cø of Motor Control Overload Relay  
SOURCE: Line side bus connection lug.  
TEMP: Temp. of connection and lug is:  
192°C / 378°F Total Temp  
- 45°C / 113°F AOT  
= 147°C / 265°F above AOT.

Note: AOT is High

Abnormal heat is being generated in motor control connection. See red arrows in PH#7 and TH#7.

TEMPERATURE ABOVE  
AOT  
147°C / 265°F

Loose and/or corroded contact area. Clean, inspect and re-secure serviceable components.

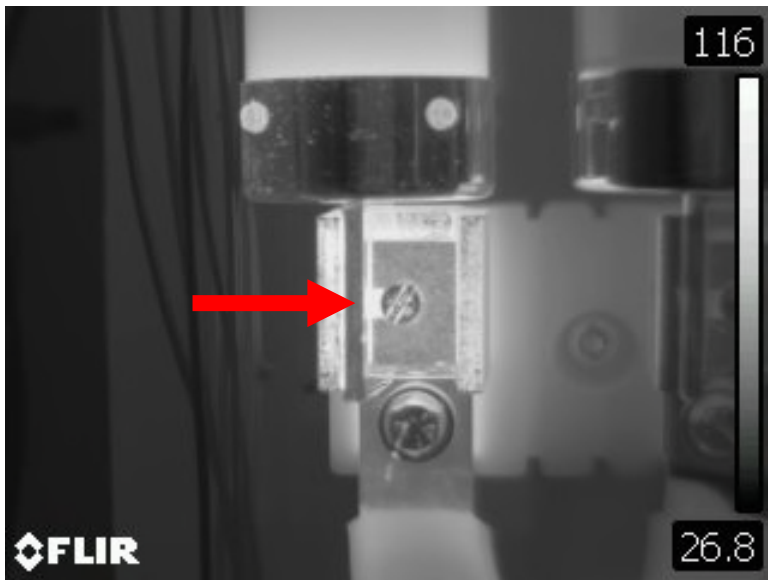
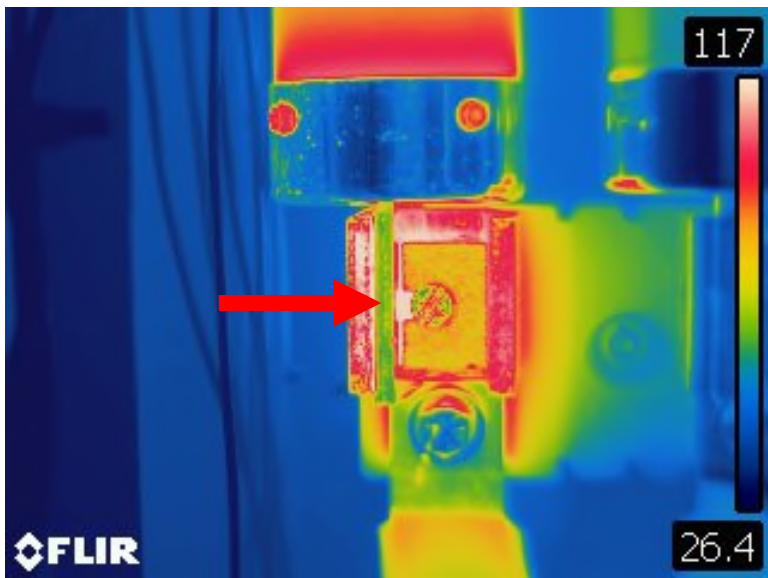
< PH # 8

PROJECT: 01100718  
CUST REP: Mike  
SCAN REP: Level 2 Technician  
DATE: July 7, 2018  
LOCATION: Precision Sleeve Area  
Box Labeled:  
Dust Collector  
Combination Starter

ITEM: Aø Fuse Block  
SOURCE: Load side fuse blade holder.  
TEMP: Temp. of blade holder is:  
144°C / 291°F Total Temp  
- 40°C / 104°F AOT  
= 104°C / 187°F above AOT.

Abnormal heat is being generated in fuse block component. See red arrows in PH#8 and TH#8.

**TEMPERATURE ABOVE  
AOT  
104°C / 187°F**

Loose and/or corroded contact area. Clean, inspect and re-secure serviceable components.

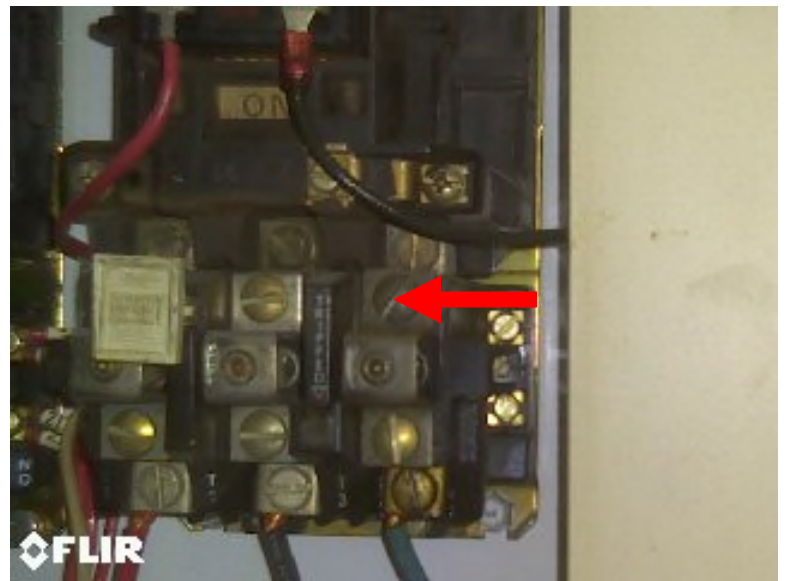
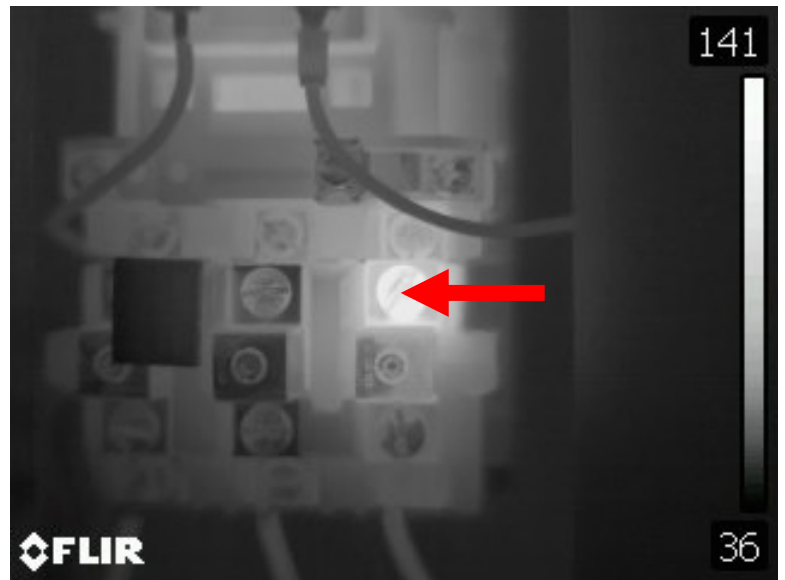
PH # 9 >

PROJECT: 01100718  
CUST REP: Mike  
SCAN REP: Level 2 Technician  
DATE: July 7, 2018  
LOCATION: Precision Sleeve Area  
Box Labeled:  
H3 Right Agitator  
Combination Starter

**ITEM:** Cø of Motor Control Overload Relay  
**SOURCE:** Line side heater connection lug.  
**TEMP:** Temp. of connection and lug is:  
155°C / 311°F Total Temp  
- 41°C / 106°F AOT  
=114°C / 205°F above AOT.

Abnormal heat is being generated in motor control component. See red arrows in PH#9 and TH#9.

**TEMPERATURE ABOVE  
AOT  
114°C / 205°F**

Loose and/or corroded contact area. Clean, inspect and re-secure serviceable components.

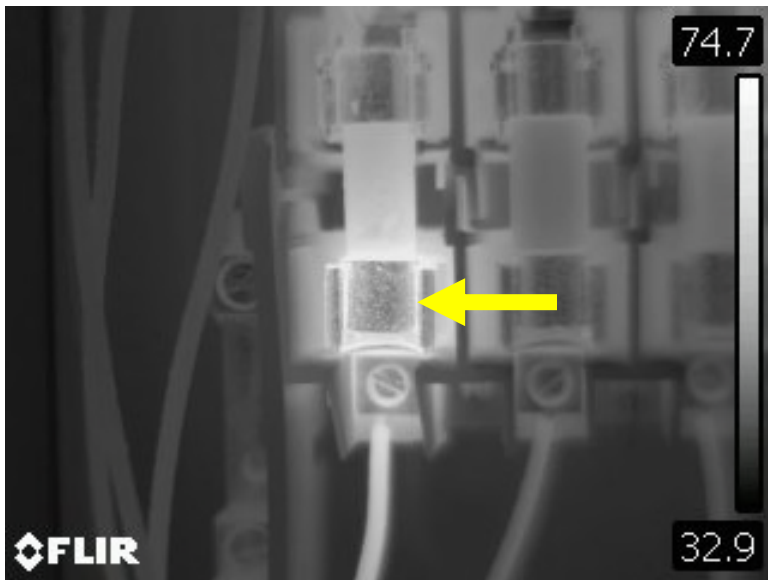
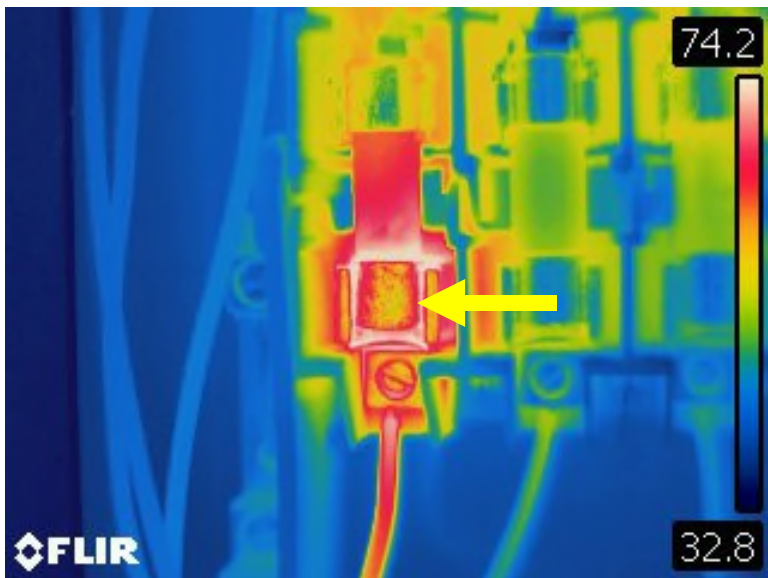
< PH # 10

PROJECT: 01100718  
 CUST REP: Mike  
 SCAN REP: Level 2 Technician  
 DATE: July 7, 2018  
 LOCATION: 152 Oven Area  
 Unlabeled Box  
 (Left of M1 Drive Cabinet)  
 Fuse Disconnect

ITEM: AØ Fuse Block  
 SOURCE: Load side fuse clip.  
 TEMP: Temp. of fuse clip is:  
 83°C / 181°F Total Temp.  
 - 45°C / 113°F AOT  
 = 38°C / 68°F above AOT.

**Note: AOT is High**

Abnormal heat is being generated in fuse block component. See yellow arrows in PH#10 and TH#10.

**TEMPERATURE ABOVE  
 AOT  
 38°C / 68°F**

Loose and/or corroded contact area. Clean, inspect and re-secure.

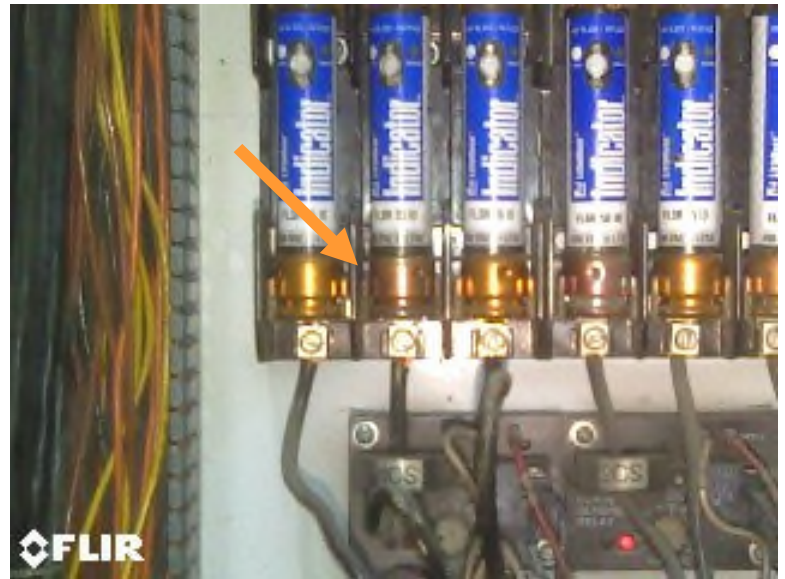
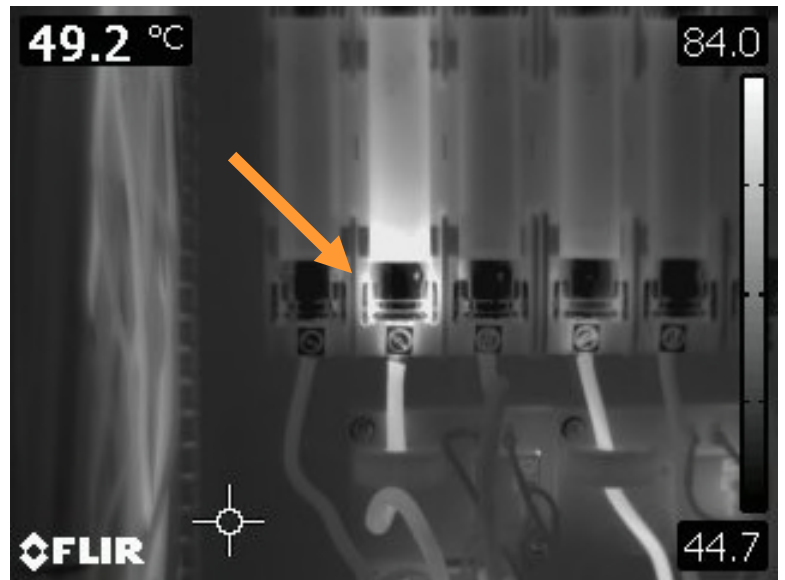
PH #11 >

PROJECT: 01100718  
 CUST REP: Mike  
 SCAN REP: Level 2 Technician  
 DATE: July 7, 2018  
 LOCATION: 152 Oven Area  
 Control Cabinet For:  
 M1 Drive  
 3ø Fused Circuit Labeled:  
 3FU

ITEM: Bø Fuse Block  
 SOURCE: Load side fuse clip.  
 TEMP: Temp. of fuse clip is:  
 101°C / 214°F Total Temp  
 - 49°C / 120°F AOT  
 = 52°C / 94°F above AOT.

Note: AOT is High.

Abnormal heat is being generated in fuse block component. See orange arrows in PH#11 and TH#11.

**TEMPERATURE ABOVE  
 AOT  
 52°C / 94°F**

Loose and/or corroded contact area. Clean, inspect and re-secure serviceable components.

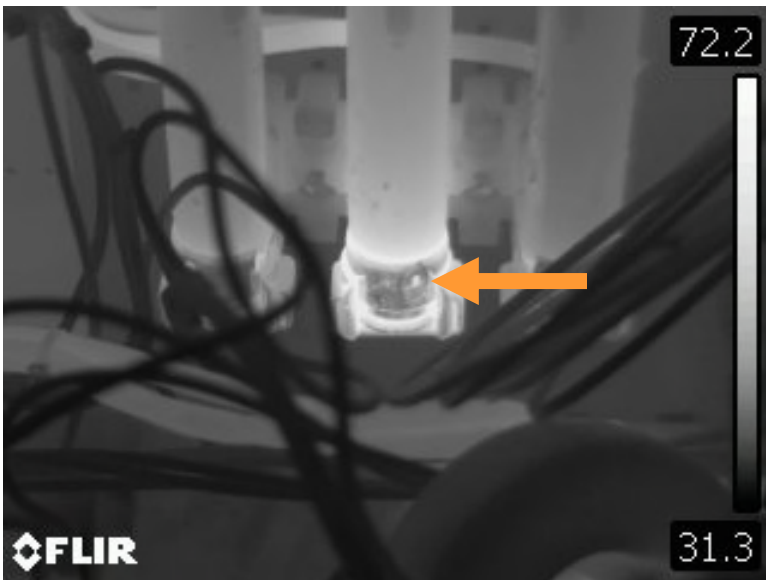
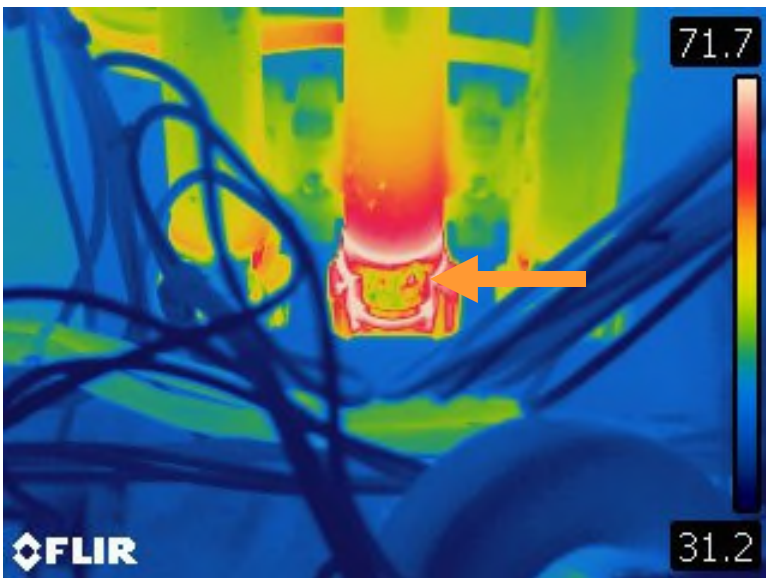
< PH # 12

PROJECT: 01100718  
CUST REP: Mike  
SCAN REP: Level 2 Technician  
DATE: July 7, 2018  
LOCATION: MOL Colt Area  
Box Labeled:  
Dust Collector  
Combination Starter

ITEM: Bø Fuse Block  
SOURCE: Load side fuse clip.  
TEMP: Temp. of fuse clip is:  
79°C / 174°F Total Temp  
- 38°C / 100°F AOT  
= 41°C / 74°F above AOT.

Abnormal heat is being generated in fuse block component. See orange arrows in PH#12 and TH#12.

**TEMPERATURE ABOVE  
AOT  
41°C / 74°F**

Loose and/or corroded contact area. Clean, inspect and re-secure serviceable components.
